# Final Report

A Thermal Distillation Process for Expanding Water Resources

Award No. 2019-33610-30171

AIL Research, Inc. 57 Hamilton Ave Hopewell, NJ 08525

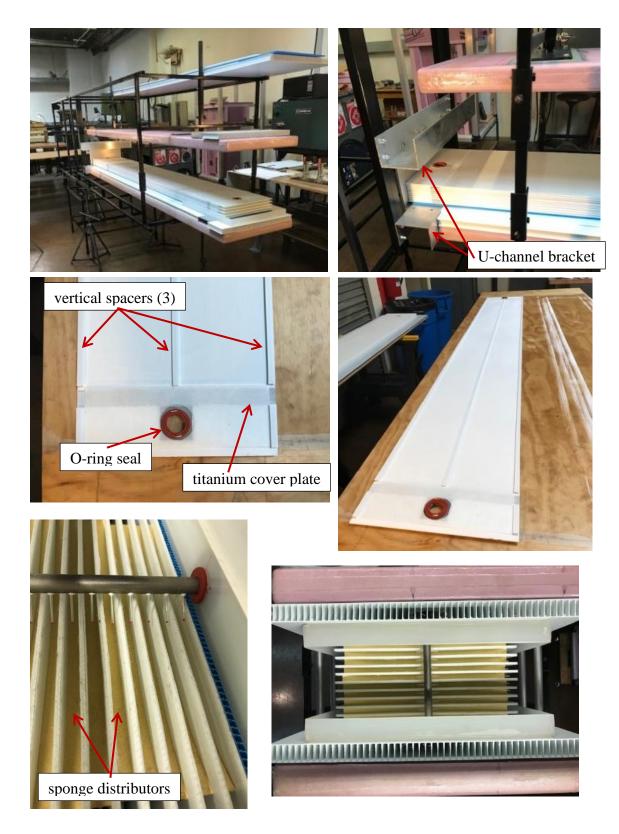
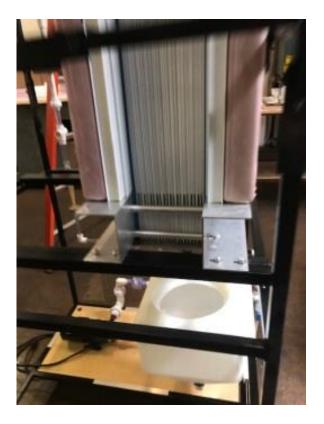
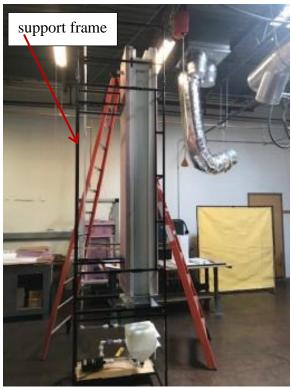
Figure 12a – Photographs of Design 4 Model

Figure 12b - Photographs of Design 4 Model

Figures 12a and 12b show photographs of the fabrication of the Design 4 model and its set-up within the support frame.

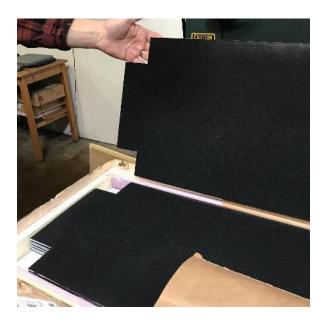
- The bubbling problem caused by the requirement to sew a knitted fabric to the 2-mm Coroplast plate was eliminated by flocking a dense layer of 20-mil nylon fibers to the surfaces of the wick plates. Flocking of the plates was performed by EIS Fibercoating (Logansport, IN). Samples of flocked plates were first received and exposed to 100°C steam for several days. With no apparent change in the exposed samples, a full set of plates, shown in Figure 19, was prepared by EIS Fibercoating.
- To reduce the buckling of the condensing plates, the stack of plates was clamped to a slightly smaller overall width. The reduced "free play" between plates greatly limited the potential for buckling.

Figure 19 – Flocked Wicking Plates

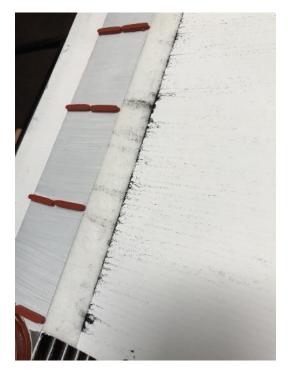
The Design 8, 10-plate model operated in March 2021 for a total of 37 hours, but never produced low conductivity condensate. One problem was caused by flock fibers that were only loosely bonded to the plates. These loose fibers washed down the plates and, as shown in Figure 21, formed clumps at the bottom of the condensing plate. These fiber clumps created paths for brine to flow from the wicks to the condensing plates.

Figure 21 – Accumulation of Loose Flock Fibers

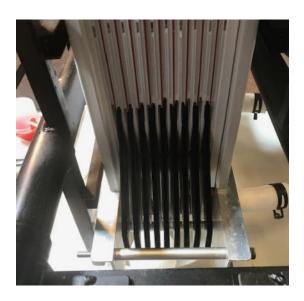
Figure 25 - Design 11 Brine Collection Gutters

The thin-film bags were replaced as the means of insuring isolation between the lower sections of the wicks and the condensing plates. Instead of the bags, the bottom edges of the wicks were centered in the gap between condensing plates by inserting the edges into chevron-shaped gutters.

When assembled the brine wicks sit within the brine gutters. A narrow layer of nonwoven fiber-glass sewn to each side of the bottom edges of the brine wicks (i.e., the "edge strips" shown in Figure 25) keep the wicks centered within the gutters. During operation when the condensing plates get hot and expand, the gutter is pulled downward by about ½" relative to the wicks. With sidewalls that are 1" in height, the bottom edges of the wicks remain within the gutters under all operating conditions.

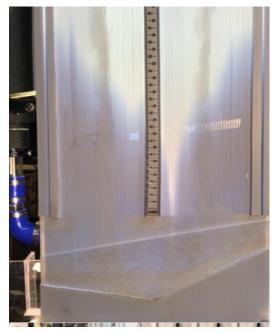
Each condensing plate has on the order of 100 internal flutes. These flutes connect to a common supply pocket at the bottom of the plate and a common collection pocket at the top of the plate. Pressure non-uniformities within the supply pocket can produce flute-to-flute flow variations.

As shown in Figure 28, a flow visualization test in which a slug of blue dye is injected into the line feeding fluid to a plate identified a zone of very low flow in the central flutes of the plate.

Figure 28 – Flow Non-Uniformity within A Condensing Plate

The zone of low flow is most likely caused by the location of the supply and collection ports for each plate, which are at the corners of the plate. (As described in a following section, future work will address the problems identified in the operation of the Design 12 model.)
